INDOOR AIR QUALITY ASSESSMENT

Veteran's Memorial Elementary School 25 Hurd Ave Saugus, MA 01906

Prepared by:
Massachusetts Department of Public Health
Center for Environmental Health
Emergency Response/Indoor Air Quality Program
August 2006

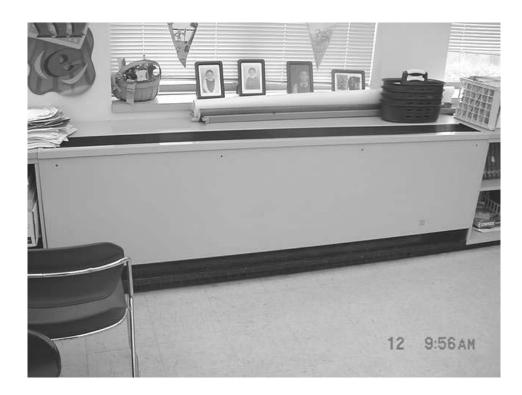
It can be seen from Table 1 that carbon dioxide levels were elevated above 800 parts per million (ppm) in twelve of thirty-nine areas surveyed, indicating poor air exchange in those areas on the day of the assessment. Fresh air in classrooms is supplied by a computerized unit ventilator (univent) system (Picture 1). A univent draws air from the outdoors through a fresh air intake located on the exterior wall of the building (Picture 2) and returns air through an air intake located at the base of the unit (Figure 1). Fresh and return air are mixed, filtered, heated/cooled and provided to classrooms through an air diffuser located in the top of the unit.

Classroom Univent

- 1. Continue with plans to make repairs to univents.
- 2. Inspect exhaust motors and belts for proper function, repair and replace as necessary.
- 3. Once repaired, operate all ventilation systems throughout the building (e.g., gym, auditorium, classrooms) *continuously* during periods of school occupancy independent of thermostat control to maximize air exchange.
- 4. Remove all obstructions from univents and exhaust vents to facilitate airflow.
- 5. Close classroom doors to improve air exchange.
- 6. Use openable windows in conjunction with mechanical ventilation to introduce fresh air. Care should be taken to ensure windows are properly closed at night and weekends during winter months to avoid the freezing of pipes and potential flooding. The opening of windows should also be limited during air conditioning season to prevent condensation (i.e., outdoor relative humidity over 70%).

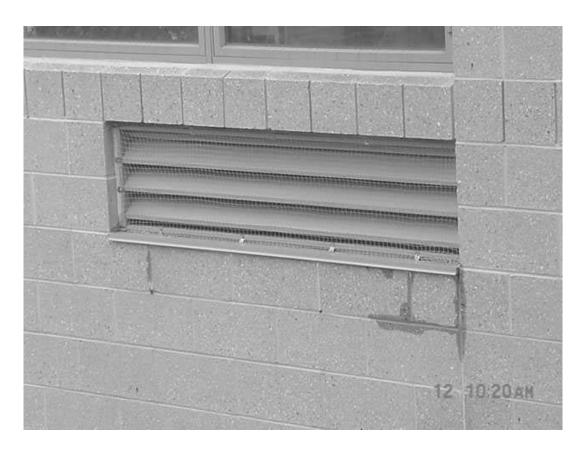
Univent Fresh Air Intake

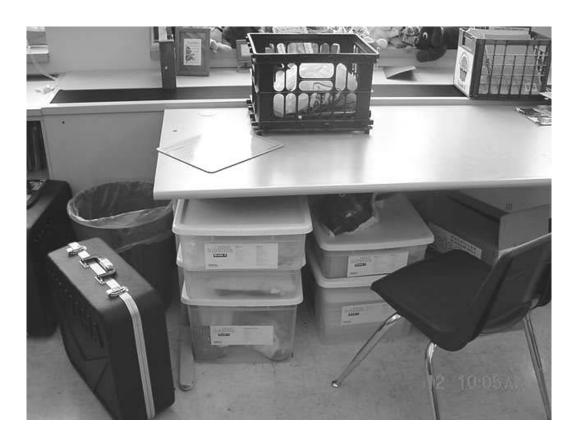
Obstructions to airflow, such as papers and books stored on univents and items placed in front

of univent returns, were seen in a number of classrooms (Picture 3). In order for univents to provide fresh air as designed, these units must be activated and allowed to operate while rooms are occupied. Univent return vents and diffusers must also remain free of obstructions.

Obstructed Univent Return Vent (along front of unit)

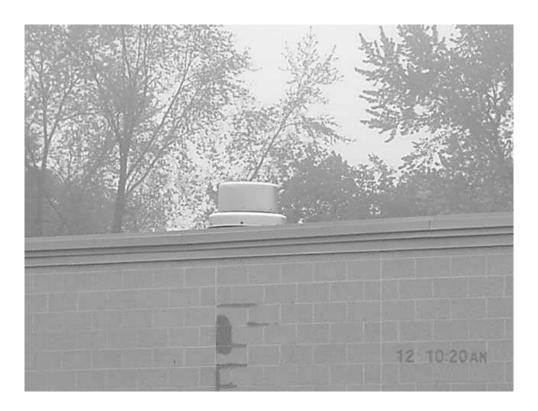
Exhaust ventilation is provided by wall-mounted vents powered by rooftop motors (Picture 4). The majority of exhaust vents were operating, however several were not during the assessment (Table 1). Exhaust vents were also found obstructed by various items in a number of areas (Picture 5), restricting airflow. As with the univents, in order to function properly, exhaust vents must be activated and remain free of obstructions.

Rooftop Exhaust Motor

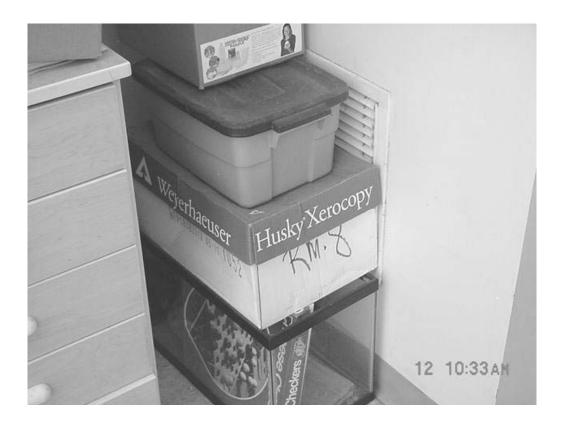
Classrooms Items Obstructing Exhaust Vent

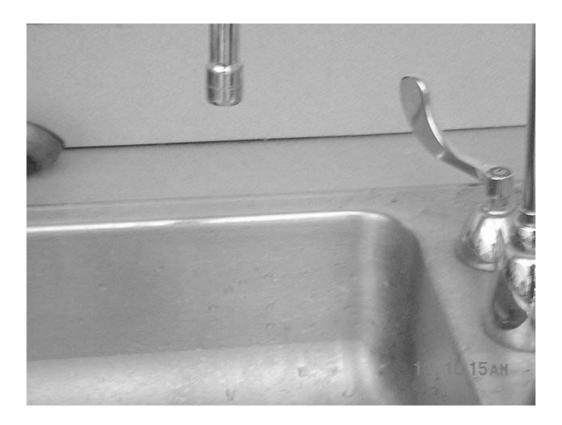
Breaches were observed between the counter and sink backsplashes in some classrooms (Picture 6). If not watertight, water can penetrate through these seams. Water penetration and chronic exposure of porous and wood-based materials can cause these materials to swell and show signs of water damage, which can subsequently lead to mold growth.

Space between Sink Countertop and Backsplash

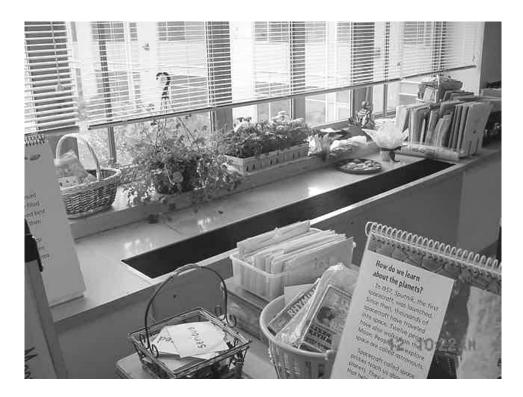
Plants were noted in several classrooms. Plants can be a source of pollen and mold, which can be respiratory irritants for some individuals. Plants should be properly maintained and equipped with drip pans. Plants should also be located away from ventilation sources (e.g., univent air diffusers/Picture 7) to prevent the entrainment and/or aerosolization of dirt, pollen or mold.

Plants near Univent Air Diffuser

- 9. Ensure plants have drip pans. Examine drip pans periodically for mold growth and disinfect with an appropriate antimicrobial where necessary. Remove plants from the air stream of univents.

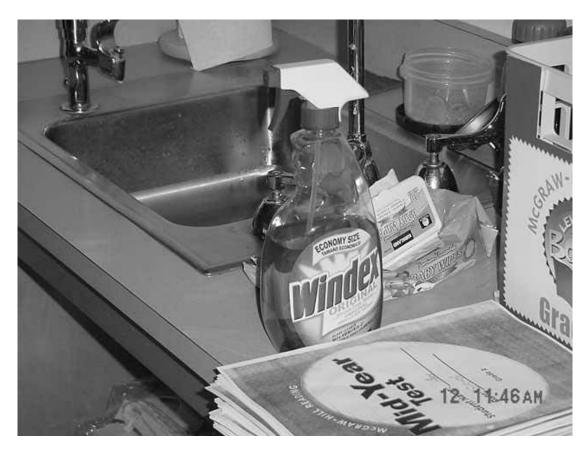
Cleaning products were found on countertops and in unlocked cabinets beneath sinks in some classrooms (Picture 8). Many of these products appeared to be brought from home possibly without the knowledge of school personnel who maintain material data safety sheets (MSDS) for chemicals used in the school. Therefore it is unlikely that MSDSs for these materials are available on site. Like dry erase materials, cleaning products contain VOCs and other chemicals that can be irritating to the eyes, nose and throat of sensitive individuals.

Spray Cleaner on Classroom Countertop

- 10. Store cleaning products properly and out of reach of students. Ensure spray bottles are properly labeled. *All* cleaning products used at the facility should be approved by the school department with MSDS' available at a central location.

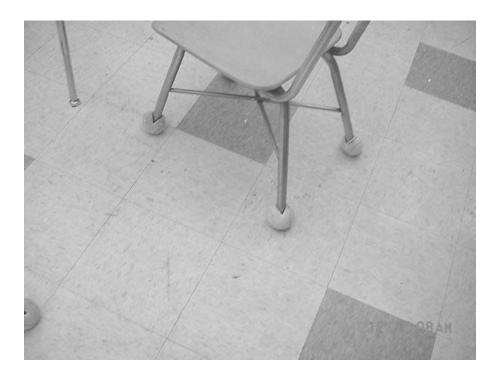
In an effort to reduce noise from sliding chairs, tennis balls had been sliced open and placed on chair legs (Picture 9) in a few classrooms. Most classrooms had alternative glides installed (Picture 10). Tennis balls are made of a number of materials that are a source of respiratory irritants. Constant wearing of tennis balls can produce fibers and cause TVOCs to off-gas. Tennis balls are made with a natural rubber latex bladder, which becomes abraded when used as a chair leg pad. Use of tennis balls in this manner may introduce latex dust into the school environment. Some individuals are highly allergic to latex (e.g., spina bifida patients) (SBAA, 2001). It is recommended that the use of materials containing latex be limited in buildings to reduce the likelihood of symptoms in sensitive individuals (NIOSH, 1997). A question and answer sheet concerning latex allergy is attached as Appendix B (NIOSH, 1998).

Tennis Balls on Chair Legs

- 12. Clean exhaust/return vents of accumulated dust periodically to prevent the aerosolization of dirt, dust and particulates.
- 13. Replace tennis balls on chair legs with alternative glides shown in Picture 10 to prevent latex dust generation.

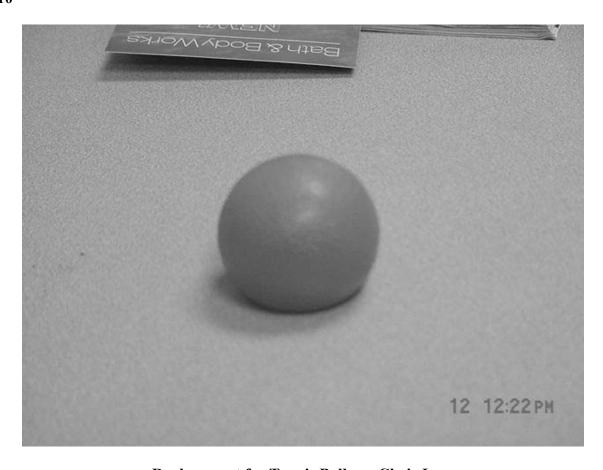
Replacement for Tennis Balls on Chair Legs

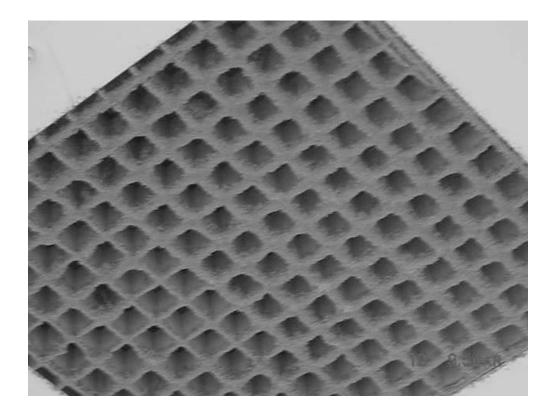
Other conditions that can affect indoor air quality were observed during the assessment. Several ceiling and wall-mounted exhaust vents were occluded with dust (Picture 11). Dust can be a source for eye and respiratory irritation. If exhaust vents are not functioning, backdrafting can occur and aerosolize dust particles. Dust particles can also be aerosolized when fans are activated. Once aerosolized, these materials can accumulate on flat

Ceiling-Mounted Exhaust Vent Occluded with Dust
